UNEVEN BRAKE WEAR PAD PROFILE CHART

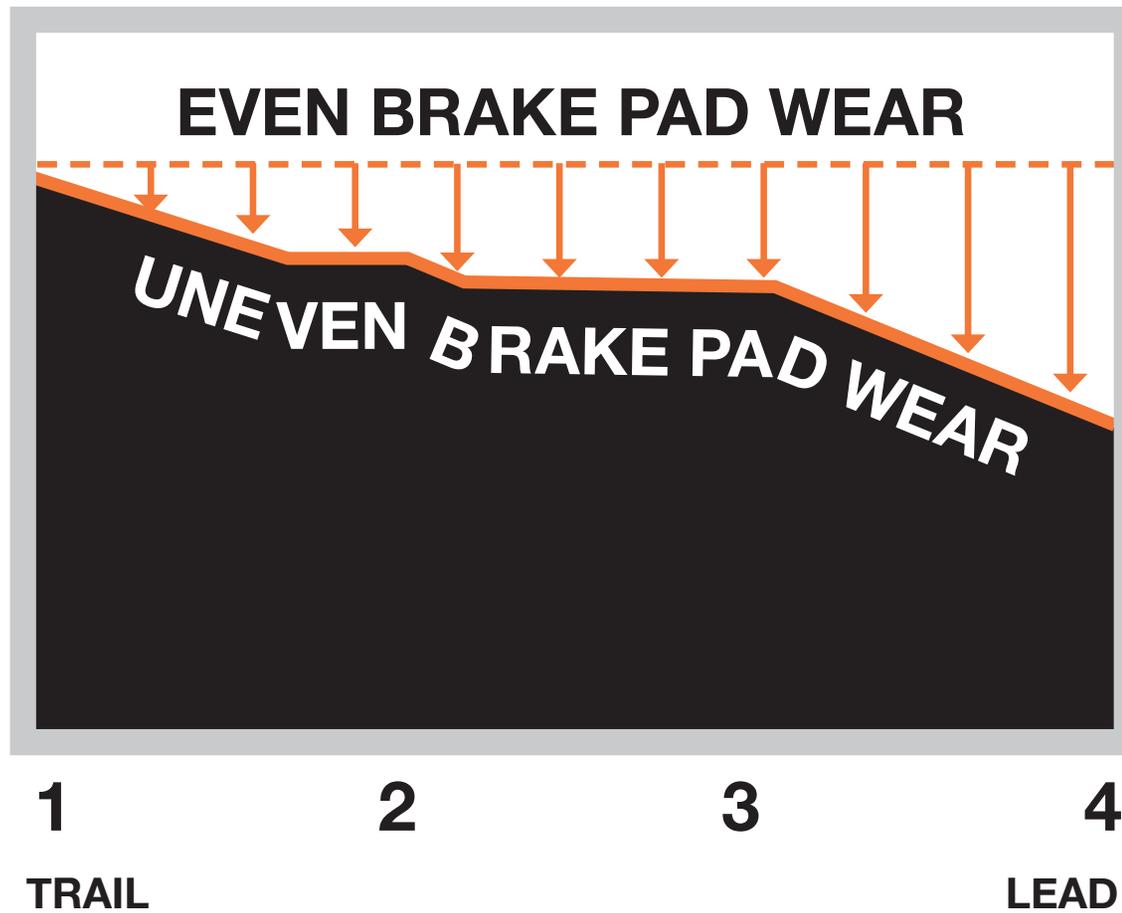
Uneven friction wear attributed to worn, corroded
or defective brake hardware reduces the life of the pad.
